INDIVIDUAL PROPERTY/DISTRICT
MARYLAND HISTORICAL TRUST
INTERNAL NR-ELIGIBILITY REVIEW FORM

Property/District Name: Holloway Hall, Salisbury State U Survey Number: WI-135

Project: Phase II Rehabilitation Holloway Hall Agency: UMS/SSU

INVENTORY FORM FOR STATE HISTORIC SITES SURVEY

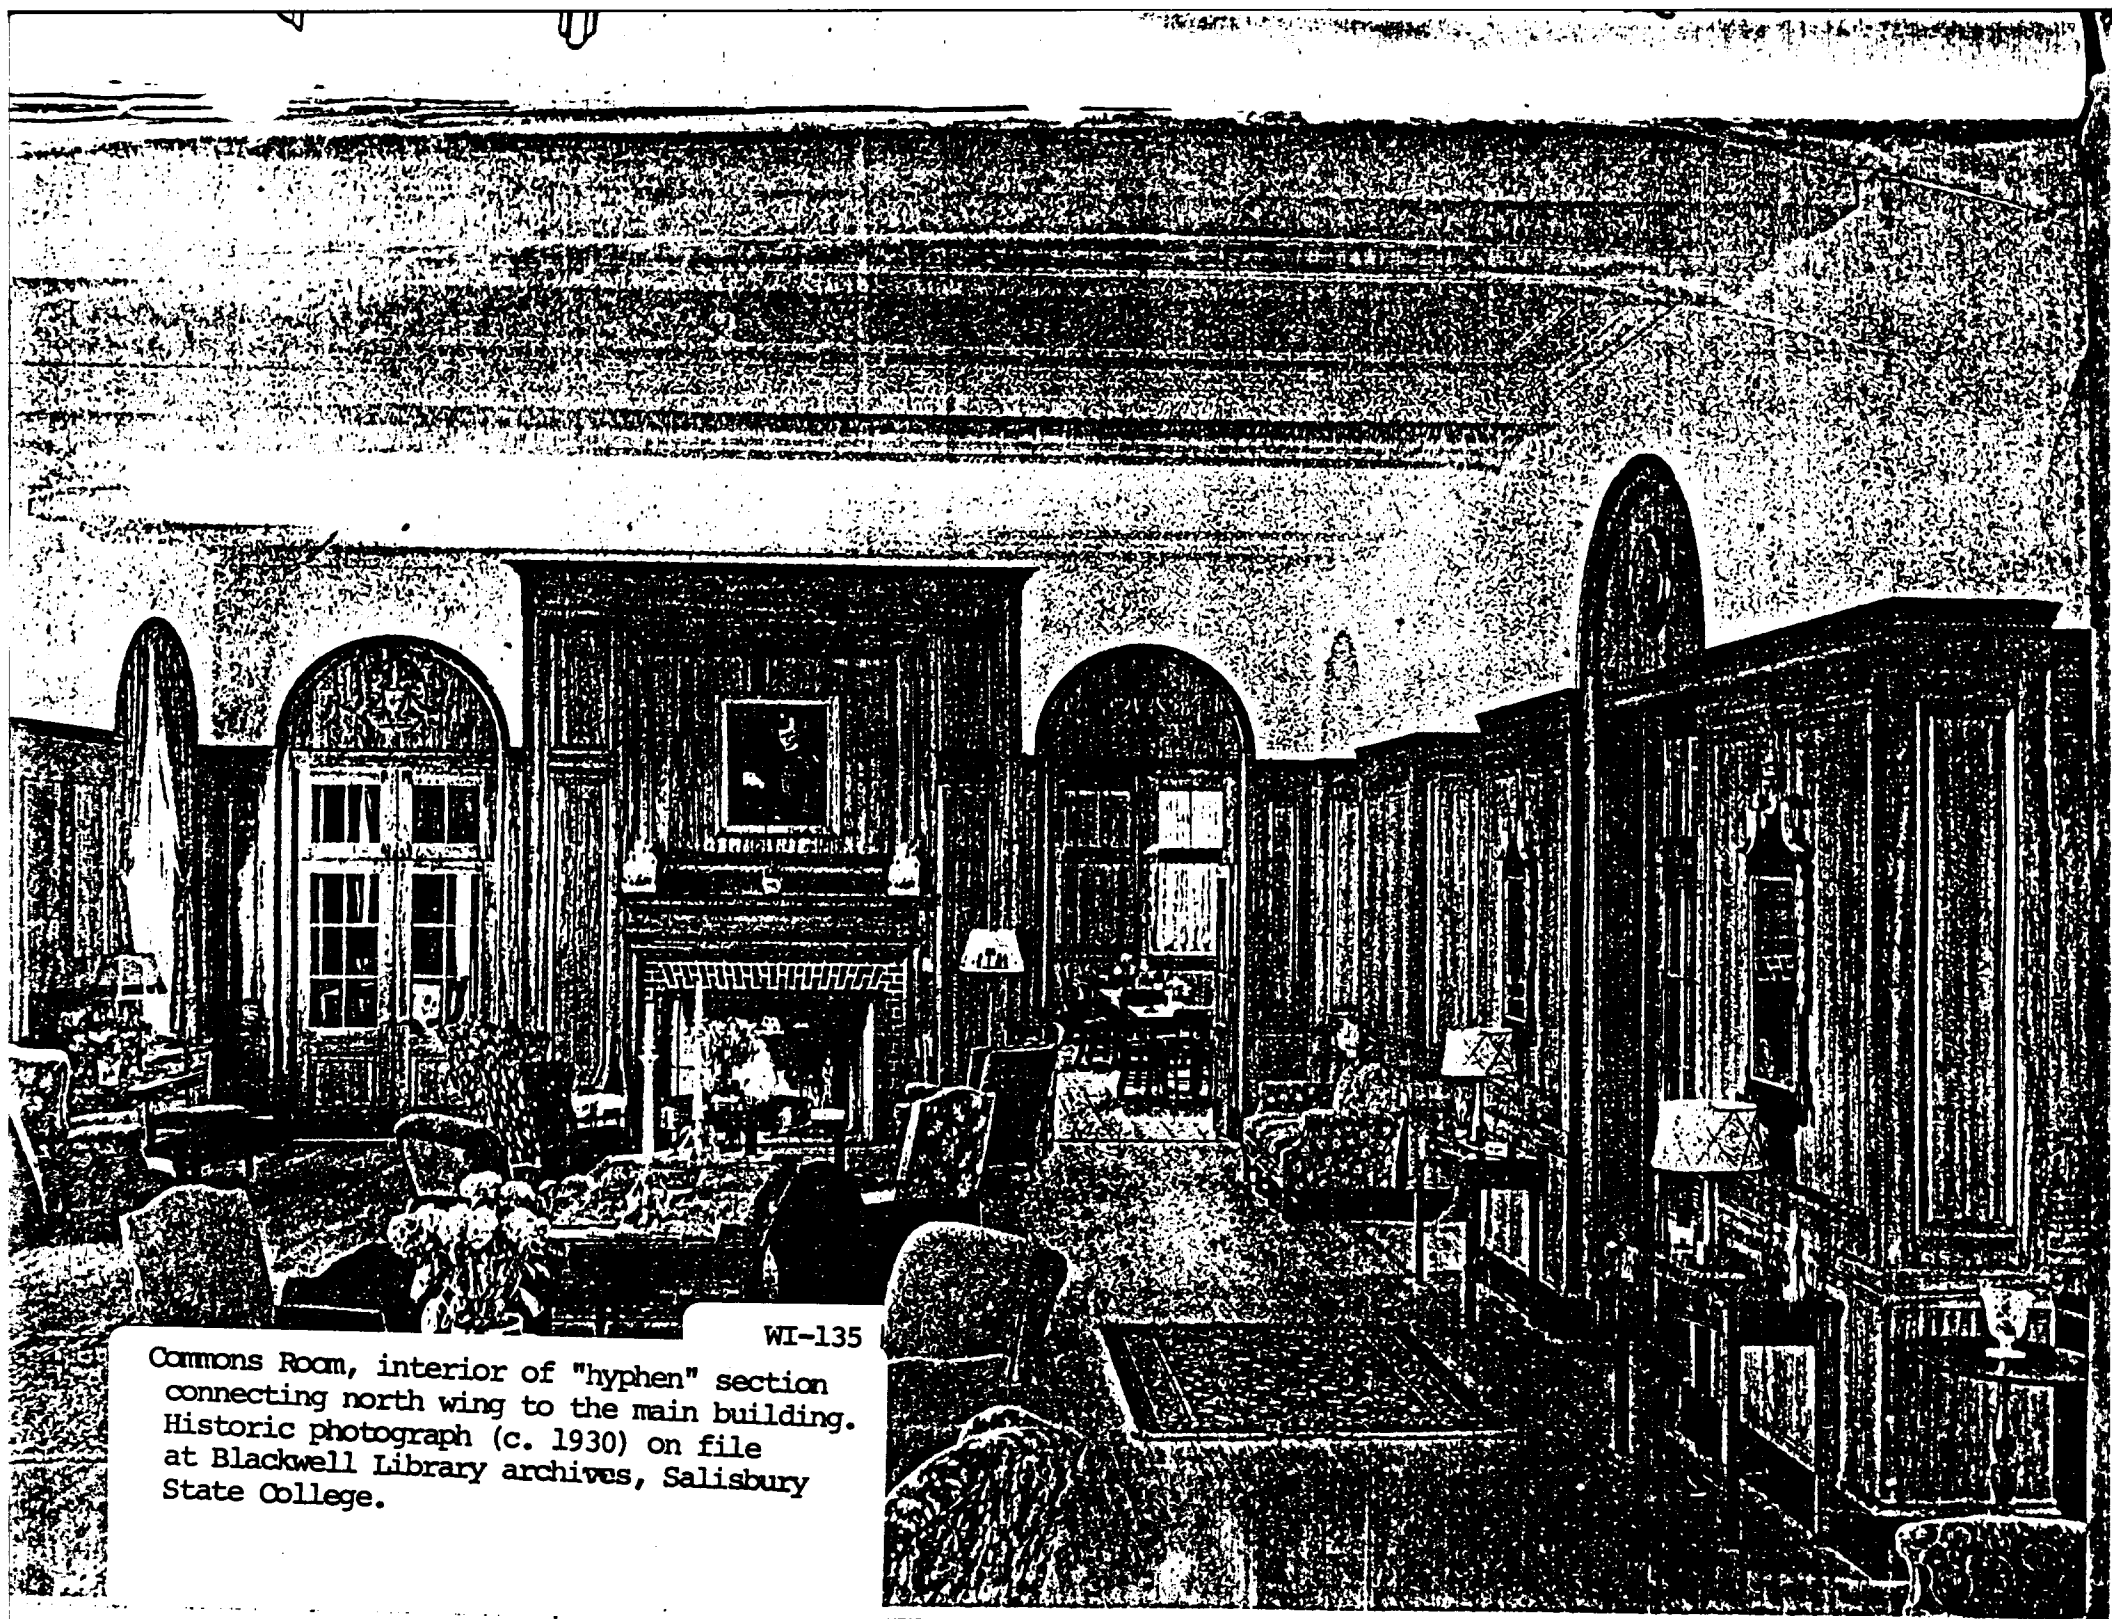
WI-135

Commons Room, interior of "hyphen" section
connecting north wing to the main building.
Historic photograph (c. 1930) on file
at Blackwell Library archives, Salisbury
State College.

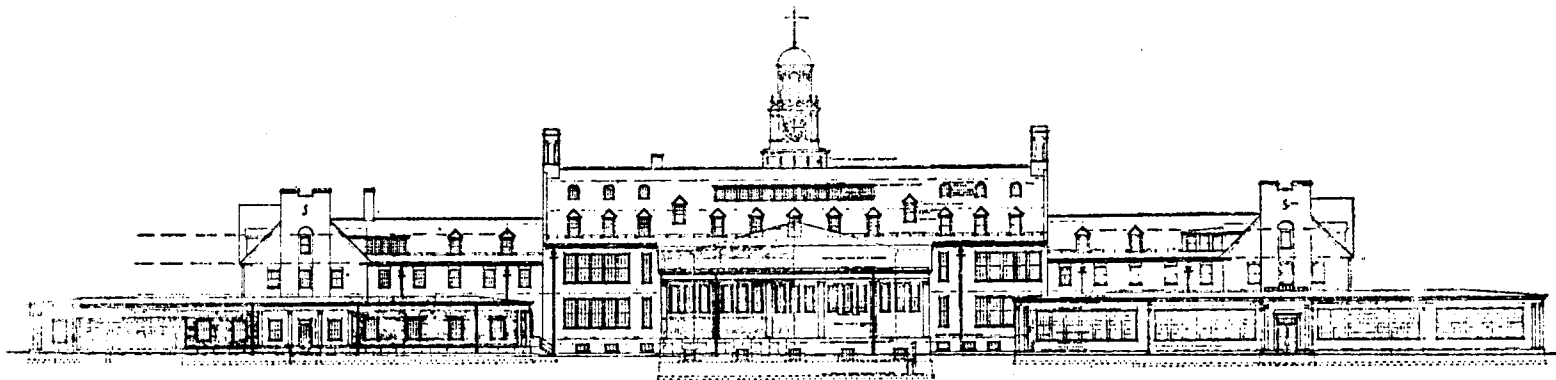
PLATE I.

REAR ELEVATION, FACING RAILROAD

FRONT ELEVATION, FACING STATE ROAD

Administration Building: Ten Classrooms, Administrative Offices, Auditorium, Gymnasium, 46 Beds on Third Floor, 18 Beds on Fourth Floor.
North Wing: Library, One Classroom, 70 Beds.
North Connecting Link: Eight Faculty Offices, 18 Beds.
In Rear: Elementary School.
South Wing: Dining Room, Kitchen, Store Rooms, 54 Beds, Infirmary.
South Connecting Link: Commons Room, 18 Beds.
In Rear: Laundry, Bakery, Garage, Tool House, Stable, Store Rooms.

Smith & May, Architects, drawings of front
and rear elevations
Reproduced from the Report of the Commission
to Study the Need for A Normal School on the
Eastern Shore to the General Assembly, 1924

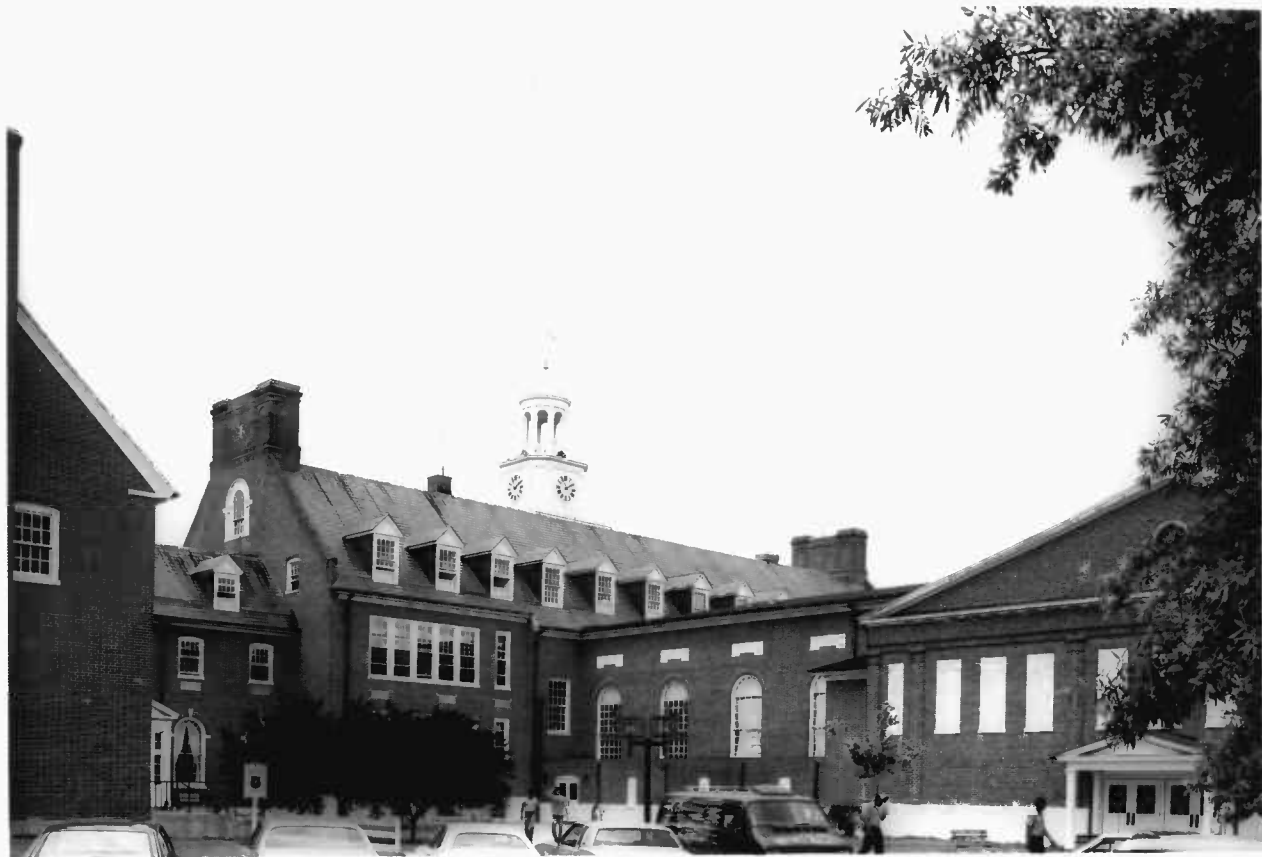
Holloway Hall
Salisbury State College
Wicomico County, Maryland
Susanne Moore
3 June 1981
Md Historical Trust, Annapolis, Md
East (rear) elevation
1/7

The rear (east) side of Holloway Hall is best viewed from a southeast vantage point into a three-sided courtyard formed by the easternmost (rear) end of the south wing, the rear facade of the main structure, and the south facade of the auditorium. The southernmost component of this visually complex view is the east facade of the south wing. This facade is dominated by a double chimney wall rising from basement to roof. In the center of

this chimney wall at first floor level is one 8/8 sash window. At second floor are three windows, one placed inside an arched opening in the chimney wall and two flanking this wall in the outer bays. At third floor level, one 6/6 sash window appears in the top of the arched chimney wall opening. All the windows have segmental brick arches and marble sills.

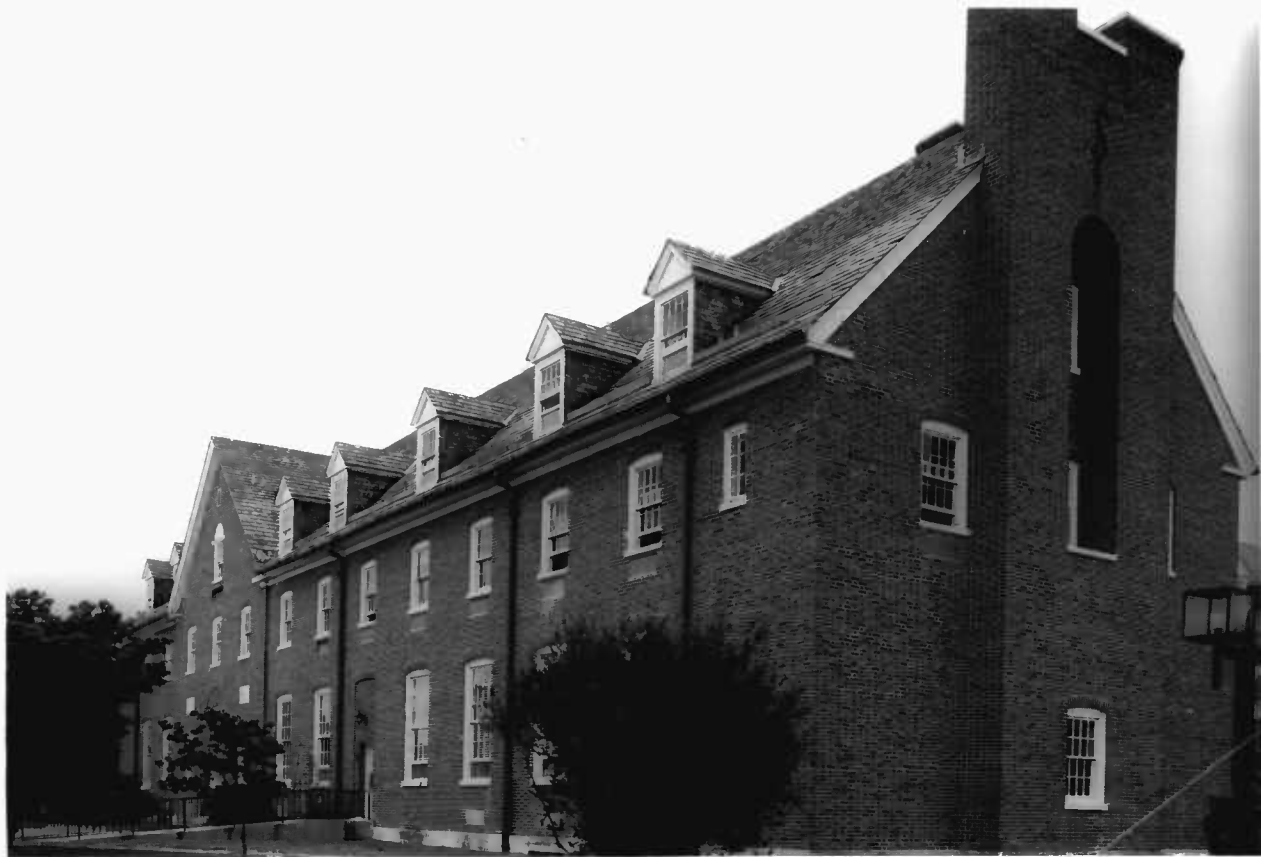
Holloway Hall
Salisbury State College
Wicomico County, Maryland
Susanne Moore
3 June 1981
Md Historical Trust, Annapolis, Md
Southeast corner, south wing
2/7

The south facade of the south wing of Holloway Hall is composed of a central three bay section, flanked on the westernmost end by a second three bay section and an 8-bay section on the easternmost end. The entire facade rests on a marble trimmed basement wall. At first floor in the westernmost section are two 12/12 sash windows, at second floor a single casement window in the westernmost bay, and moving eastward, two 8/8 sash windows. At third floor are two dormer windows, 8/8 sash. All windows and dormers are trimmed in the same fashion as those corresponding on the front facade.

The center section's three first floor windows are 12/12 sash with the center window surrounded by a corbeled brick arch. Small square stone tablets are set into the wall above the two windows flanking the center. At second floor are three windows, 8/8 sash. First and second floor windows are trimmed identically to those corresponding to those on the west end of the facade. At third floor one 8/8 sash window is set into a rounded corbeled brick arch. The roof line ends in a gable front a short distance above the third floor window.

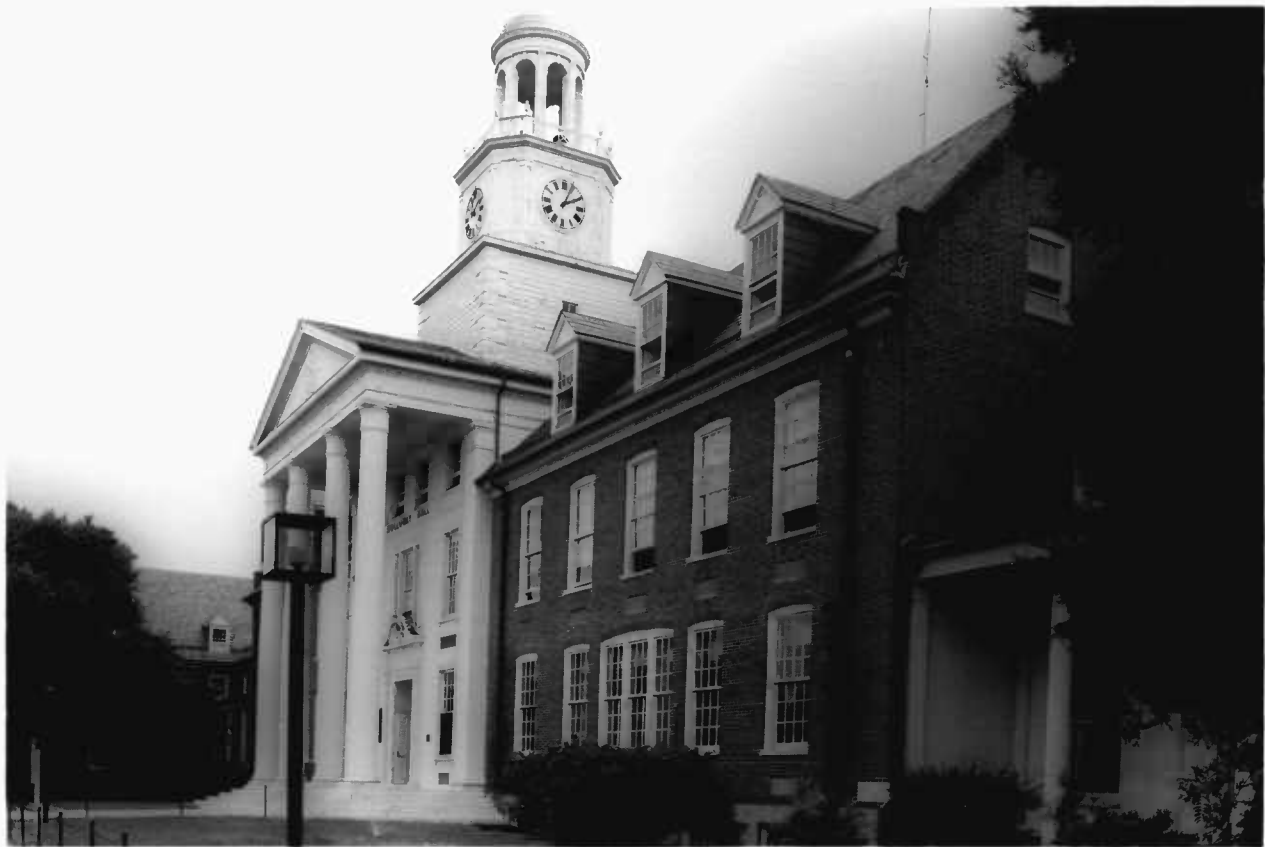
3/7

Md Historical Trust, Annapolis, Md
Front (west) facade, camera facing
northeast

The front (west) facade of Holloway Hall is symmetrical, and was constructed to replicate, albeit at a much larger scale, typical "Maryland Colonial" design of the 18th century. To this end, the main building stretches 13 bays in length, and is punctuated by a three bay wide central block with pedimented porch and clock tower. Appended to the gable ends of this structure are slightly recessed 5 bay long sections, which replicate "hyphens", and connect the main structure with north and south wings, which are placed perpendicular to the main building.

The main center block of the structure is three stories tall and is dominated by a 3-story pedimented porch which projects approximately 12 feet from the front wall plane. The porch roof rests on a row of four columns at the front edge of the porch. The columns are a modified Doric design, with elongated, floriated capitals, and are set into square marble bases. The structural material of these columns could not be determined, since they have been stuccoed and painted to match the front wall under the porch roof. The floor of the porch is brick with marble trim. The porch is

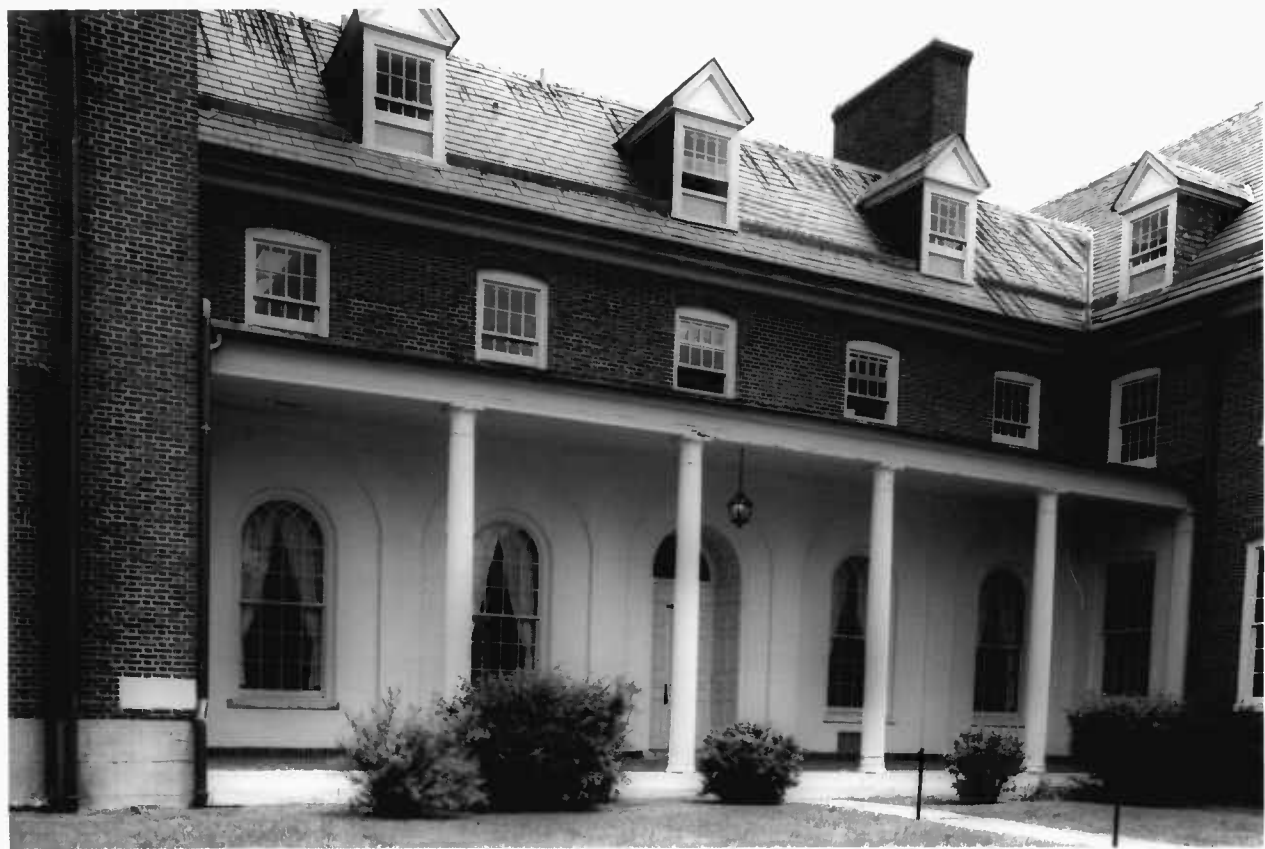
3 June 1981
Front (west) facade, section connecting
south wing to main structure
4/7

Flanking the main section of the building are identical 3-story brick sections which connect north and south wings to the main structure. These sections are shorter than the central block of the building, and are recessed about 6 feet from the front wall plane. At first floor level, one story flat roofed porches rest on six wooden columns. Here, the end columns are engaged to the side walls of north and south wings. The columns

are of modified Doric style with elongated capitals. The porches are raised from ground level by two marble steps and floored with brick laid in herringbone pattern. At first floor level beneath the porch roofs, double doors are centered in the stuccoed and painted walls. Leaded fanlights surmount the doorways. Simple lanterns hang from the centers of the porch ceilings. The centered doorways are flanked by two windows each side, set into the front wall plane inside 2-inch recessed arches with no other trimmings. The windows are 8/12 sash with Gothic tracery patterned glass filling the arches over the top sash.

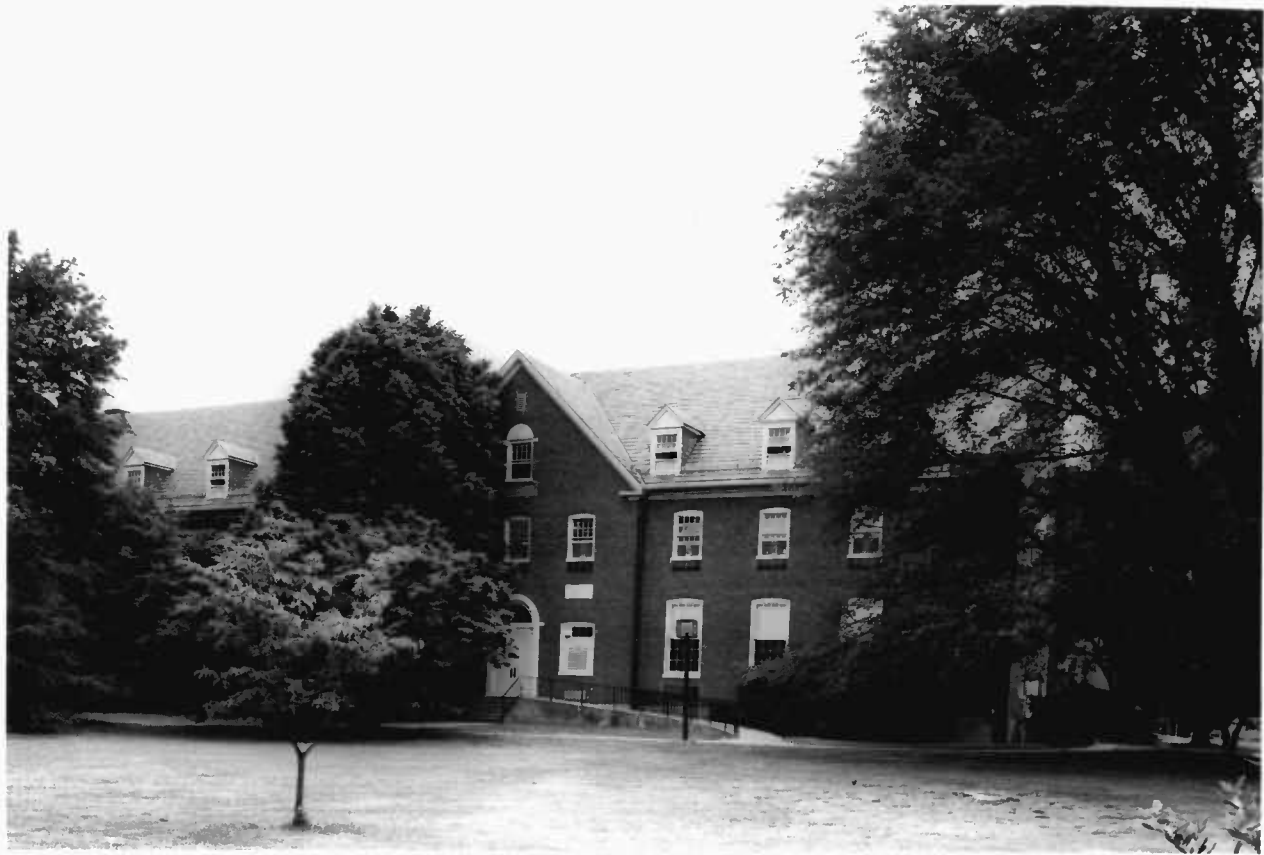
5/7

Northeast corner, north facade north
wing

The north facade of Holloway Hall, beginning at the northeast corner, includes the front facade of the former elementary school and the north facade of the north wing. The front of the one-story elementary school is four bays wide, with two windows east of the center doorway and one west of it. Windows are 8/8 sash with segmental arches and stone sills. Stone tablets are set into the wall above the windows. Corners of the front facade are bracketed by pairs of engaged wooden pillars. At center, three concrete steps lead to a pedimented arched doorway with painted wood paneled vestibule. The roofline is flat, and is marked by a simple wooden cornice. The west facade of the elementary school is visible from this view, and is four bays wide, with windows and engaged pillars at the far south corner as on the front facade.

Adjoining perpendicularly to the elementary school is the north facade of the north wing. The facade consists of a central three-bay section, flanked by a six-bay section on the easternmost end and a three-bay section on the westernmost end. The three-story central section contains a center double doorway at first floor, elevated from the ground by a flight of eight concrete steps with iron railings. The doorway is surmounted by a leaded glass fanlight which is topped by a rounded brick arch. Windows flank either side of the doorway, 8/8 sash, and stone tablets have been set into the wall above the windows. At second floor are three 8/8 sash windows, trimmed as those on the first floor. At third floor under the gable end of the roof is one 8/8 sash rounded arch window. The flanking side sections are

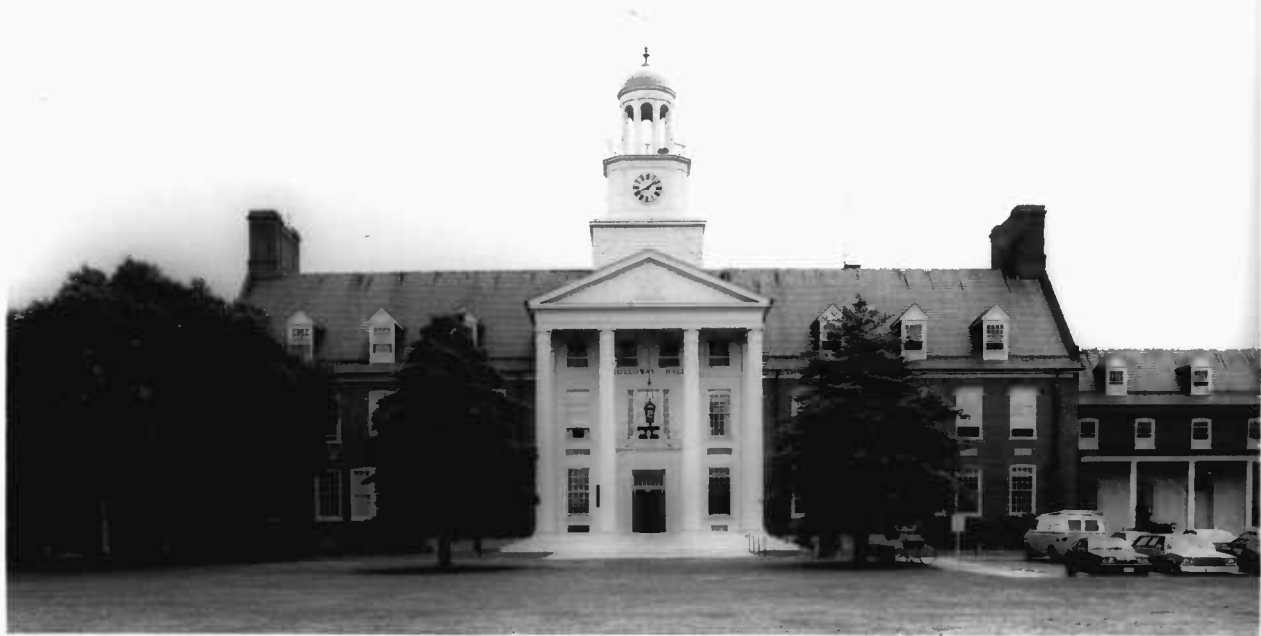
6/7

Front (west) facade, main entrance

At first floor center are double doors with an elaborate Federal style door surround featuring engaged fluted wooden columns on either side of the doors and milled scrollwork surmounting an overlight of two rows of 7 small panes each. The doorway rests on a single marble step, and is flanked by a pair of 12/12 sash windows with simple wooden trim and marble sills.

The simple wooden frieze crossing above the columns is trimmed with a small band of molding, some portions of which have deteriorated and fallen away. Four round wooden lozenges along the frieze mark the centers of the columns below. The center of the wood trimmed pediment is stuccoed and contains the seal of the State of Maryland in stone.
